Subject: Slurry Wall Reconstruction - CQA Acceptance Report
 Gary Sanitary Landfill
 Gary, Indiana

Construction Quality
Assurance Acceptance
Report

Slurry Wall Repair
Gary Landfill
Gary, Illinois

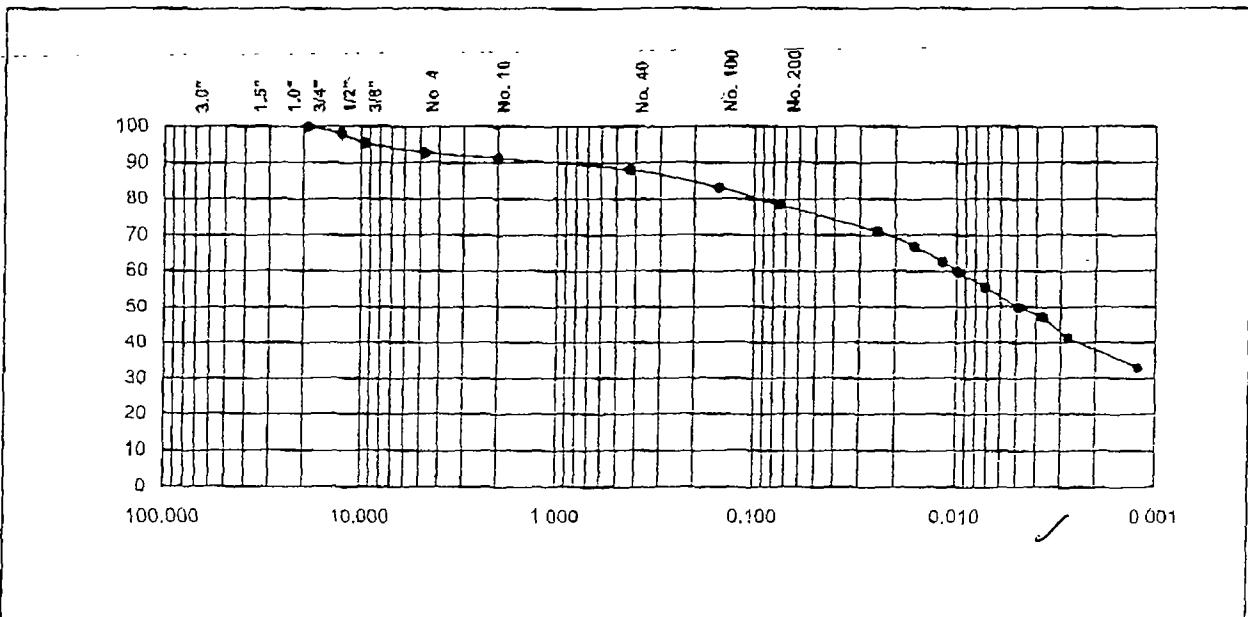
SM

Sample Location	Northside Stock Pile
Sample Description	Gray Clay (ENTERPRISE TRUCKING CO., INC.)

% + 3"	% Gravel	% Sand	% Silt	% Clay
0.0	7.2	14.4	28.2	50.2

Sieve Size	Percent Passing	Liquid Limit, L_L	Plastic Limit, P_L	Plasticity Index, PI
3.0"	100.0	26 ✓	14	12 ✓
1.5"	100.0			
1.0"	100.0			
3/4"	100.0			
1/2"	98.1			
3/8"	95.6			
No. 4	92.8			
No. 10	81.3			
No. 40	88.0			
No. 100	83.0			
No. 200	78.4

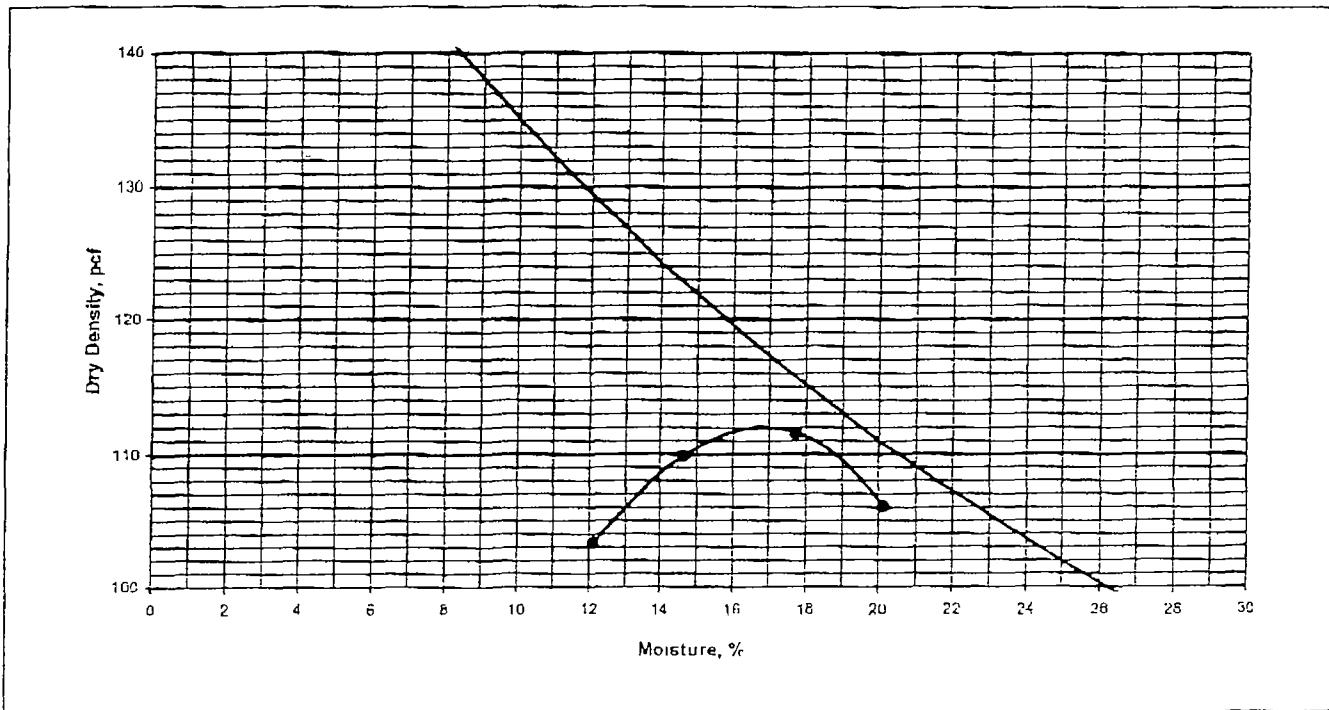
Project	Gary Landfill						
Client	Earth Tech, Inc. 3121 Butterfield Road, Oak Brook, IL 60523 Attn.. Mr. Andy Querio						
File No.	2315	Sample #	S#1	Date Tested	2/1/2002	Tested By	AK
						QC By	SM

Results	Maximum Dry Density, pcf	112.0	Optimum Moisture Content, %	17.0	Natural Moisture Content, %	18.3
---------	--------------------------	-------	-----------------------------	------	-----------------------------	------

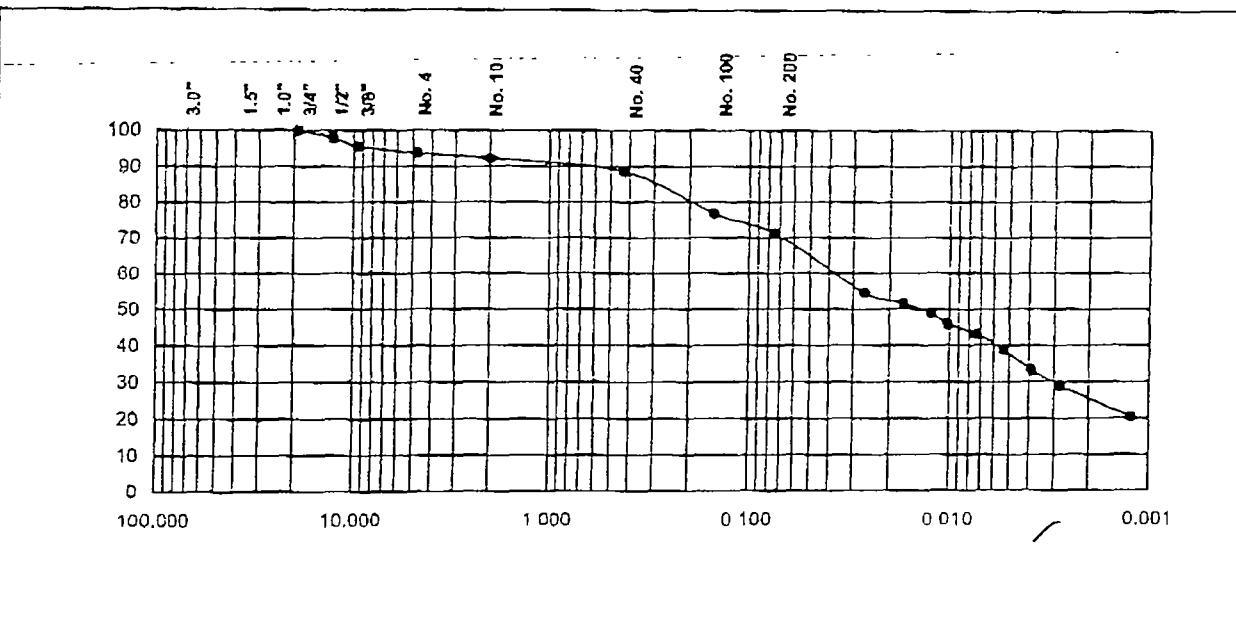
Project	Gary Landfill						
Client	Earth Tech, Inc. 3121 Butterfield Road, Oak Brook, IL 60523 Attn.: Mr. Andy Querlo						
File No.	2315	Sample #	S#2	Date Tested	2/18/2002	Tested by	MC
						Qc by	SM

% + 3"	% Gravel	% Sand	% Silt	% Clay
0.0	6.3	22.5	34.1	37.1

Sieve Size	Percent Passing	Liquid Limit, L_L	Plastic Limit, PL	Plasticity Index, PI
3.0"	100.0	22	12	10
1 5"	100.0			
1 0"	100.0	Soil Classification: CL	Soil Description: Lean Clay with Sand	System: USCS
3/4"	100.0			
1/2"	98.0			
3/8"	95.6			
No. 4	93.7			
No. 10	92.2			
No. 40	88.6			
No. 100	76.8			
No. 200	71.2

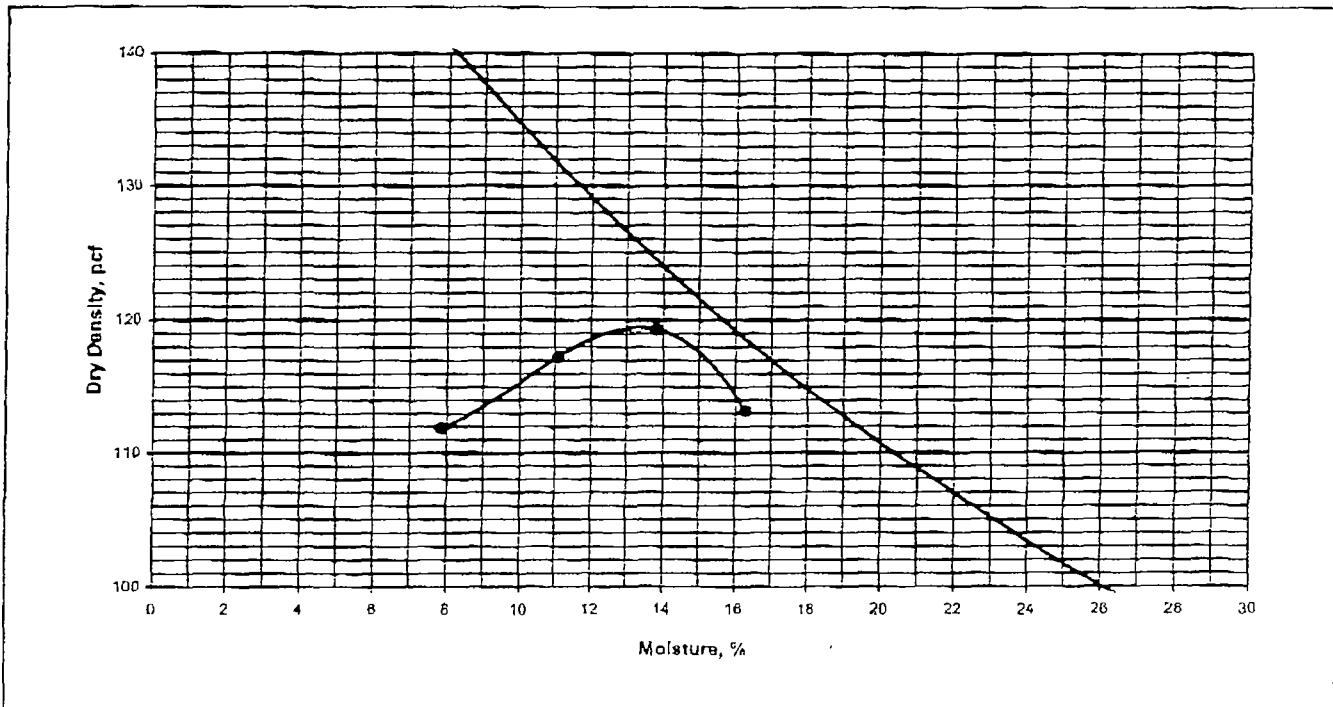
Project	Gary Landfill						
Client	Earth Tech, Inc. 3121 Butterfield Road, Oak Brook, IL 60523 Attn.: Mr Andy Querlo						
File No.	2315	Sample #	S#2	Date Tested	2/19/2002	Tested By	AK
						Qc By	SM

Results	Maximum Dry Density, pcf	Optimum Moisture Content, %	Natural Moisture Content, %
	119.5	13.5

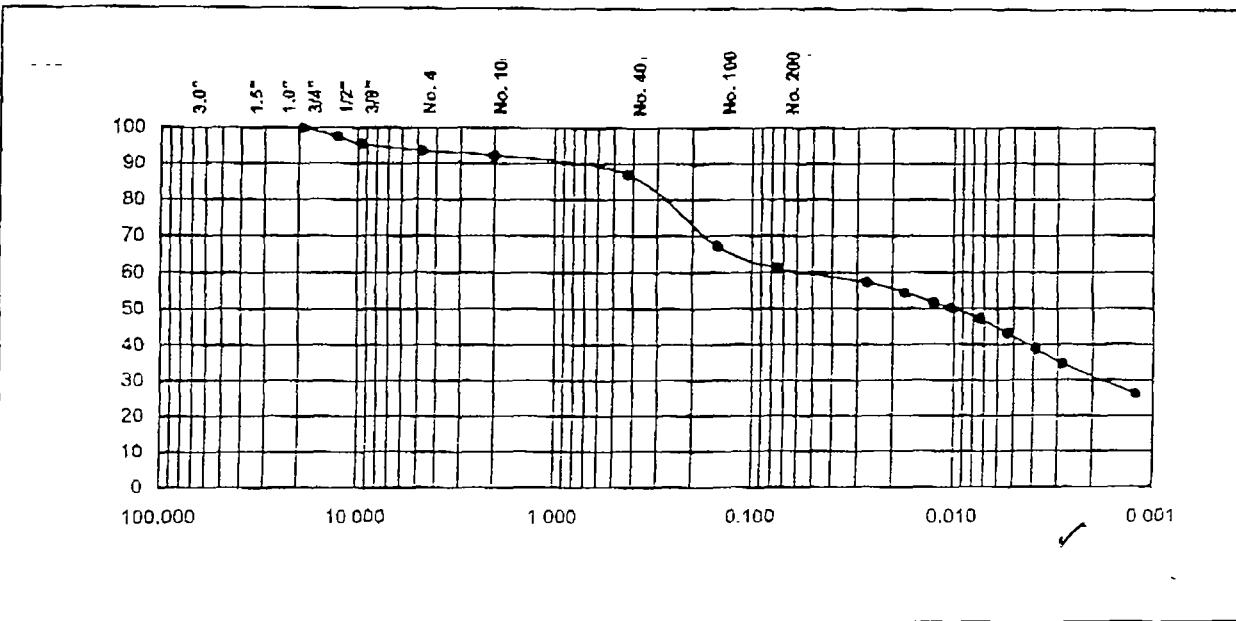
Project	Gary Landfill					
Client	Earth Tech, Inc. 3121 Butterfield Road, Oak Brook, IL 60523 Attn., Mr Andy Querio					
File No.	2315	Sample #	S#3	Date Tested	2/16/2002	Tested by MC
					Qc by SM

% + 3"	% Gravel	% Sand	% Silt	% Clay
0.0	6.4	32.5	19.3	41.9

Sieve Size	Percent Passing	Liquid Limit, L_L	Plastic Limit, PL	Plasticity Index, PI
3.0"	100.0	23	12	11
1.5"	100.0			
1.0"	100.0			
3/4"	100.0			
1/2"	97.6			
3/8"	95.4			
No. 4	93.6			
No. 10	92.2			
No. 40	87.0			
No. 100	67.2			
No. 200	61.1

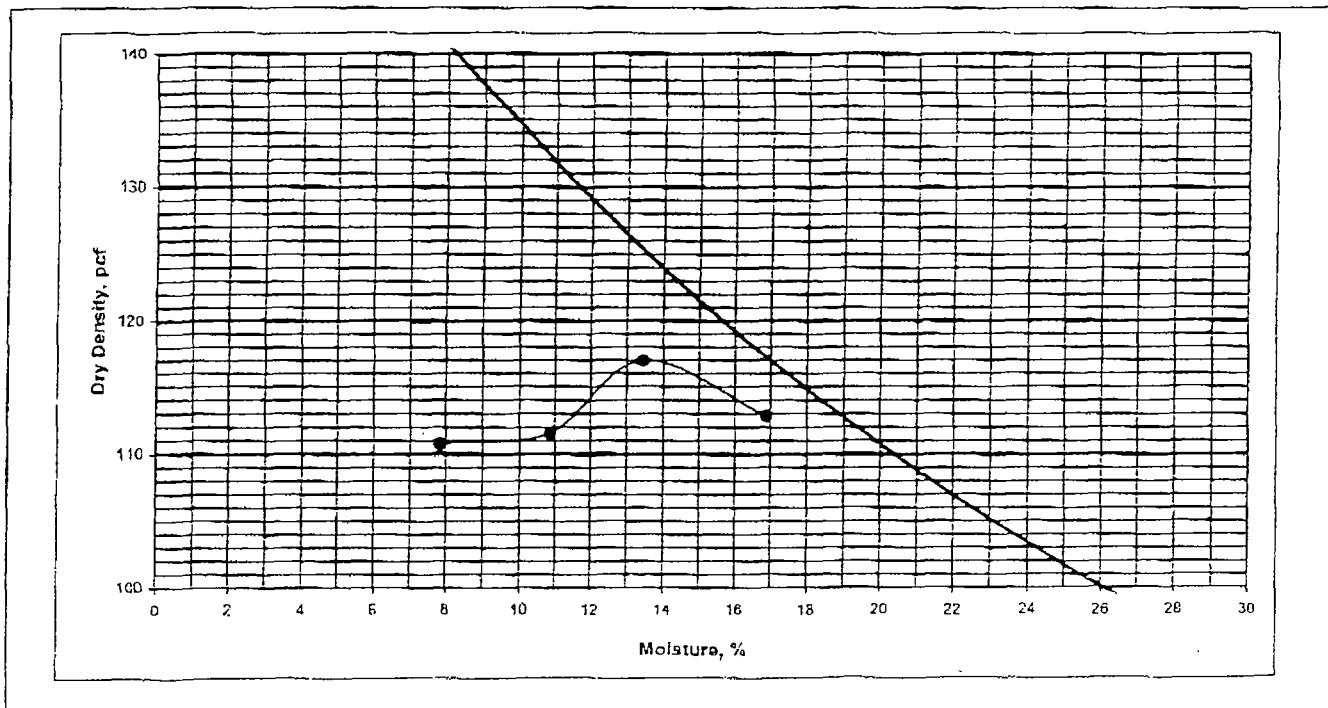
Project	Gary Landfill						
Client	Earth Tech, Inc. 3121 Butterfield Road, Oak Brook, IL 60523 Attn.: Mr. Andy Querio						
File No.	2315	Sample #	S#3	Date Tested	2/19/2002	Tested By	AK
						Qc By	SM

Results	Maximum Dry Density, pcf	Optimum Moisture Content, %	Natural Moisture Content, %
	117.0	13.5

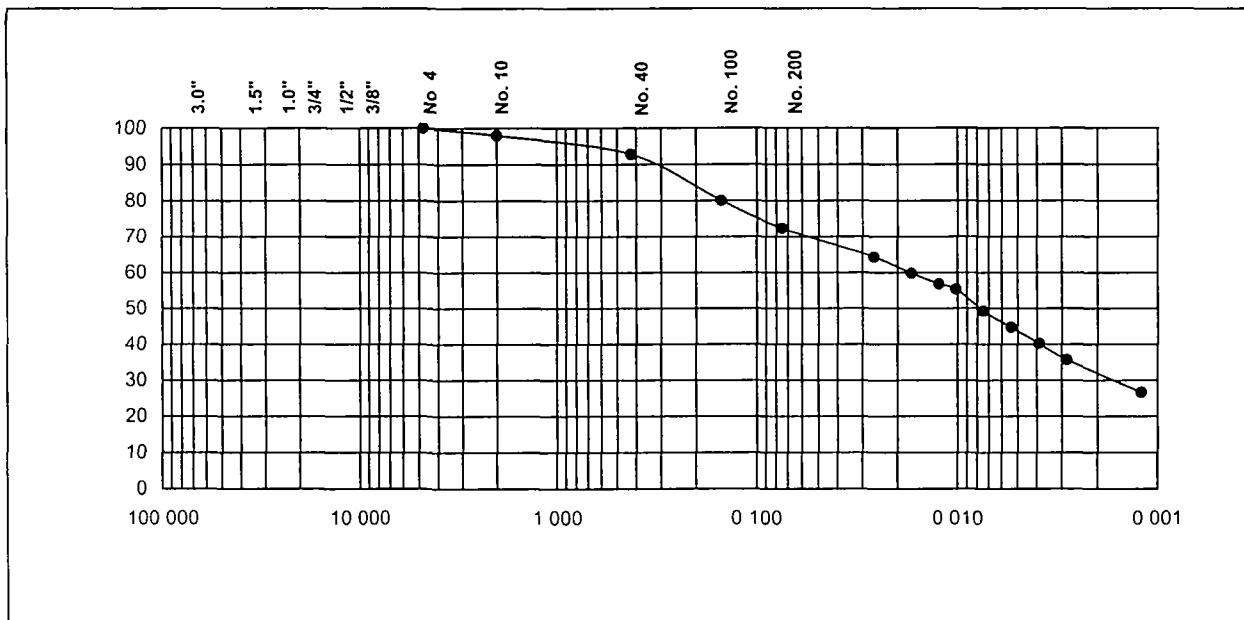
Project	Gary Landfill					
Client	Earth Tech, Inc. 3121 Butterfield Road, Oak Brook, IL 60523 Attn.: Mr. Andy Querio					
File No.	2315	Sample #	C S-1	Date Tested	4/30/2002	Tested by
					MC	Qc by

% + 3"	% Gravel	% Sand	% Silt	% Clay
0 0	0 0	27.7	29 1	43.3

Sieve Size	Percent Passing	Liquid Limit, L _L	Plastic Limit, PL	Plasticity Index, PI
3 0"	100 0			
1 5"	100 0	25	13	12
1 0"	100 0			
3/4"	100 0			
1/2"	100 0			
3/8"	100 0			
No. 4	100 0			
No. 10	97 9			
No. 40	92 8			
No. 100	80 0			
No. 200	72 3

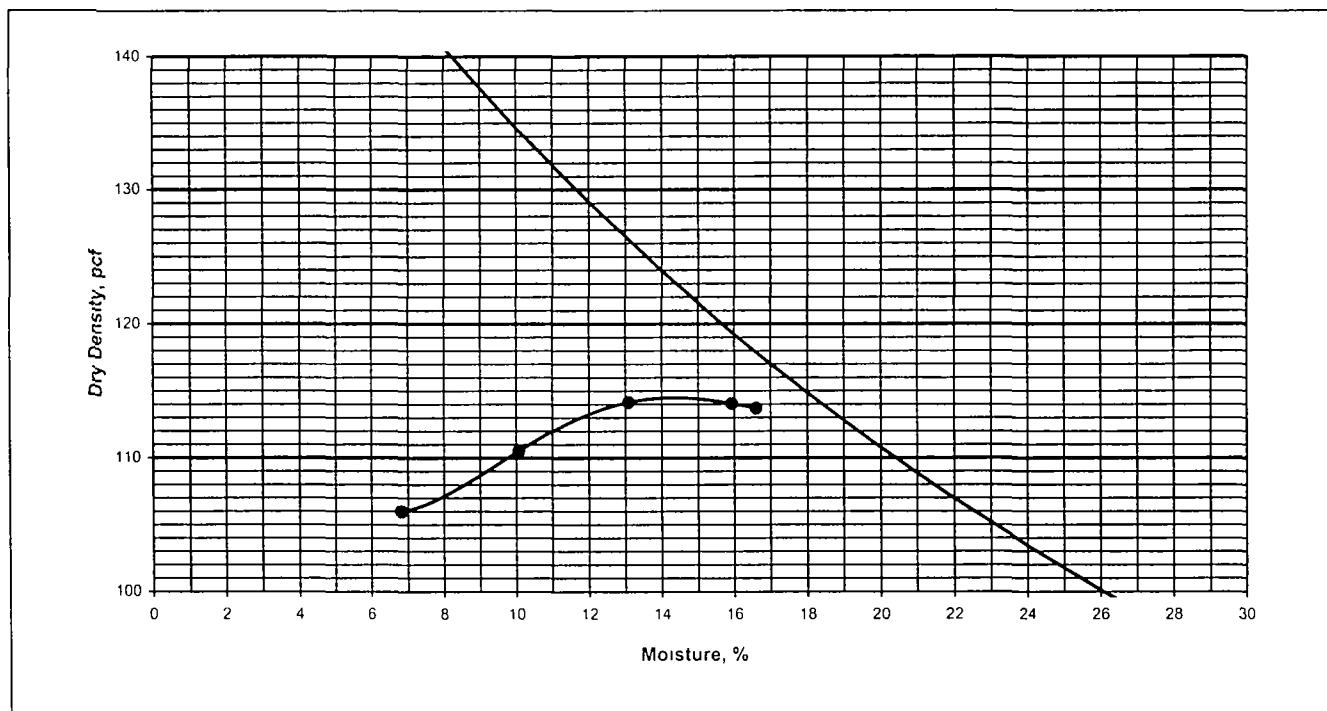
Project	Gary Landfill						
Client	Earth Tech, Inc. 3121 Butterfield Road, Oak Brook, IL 60523 Attn.. Mr. Andy Querio						
File No.	2315	Sample #	CS-1	Date Tested	4/30/2002	Tested By	NP
						Qc By	SM

Results			
Maximum Dry Density, pcf 114.5	Optimum Moisture Content, % 14.5	Natural Moisture Content, % 17.4
